Navajo Abandoned Uranium Mine

Site Screen Report

Charles Huskon No. 9 AUM Site

January 2011

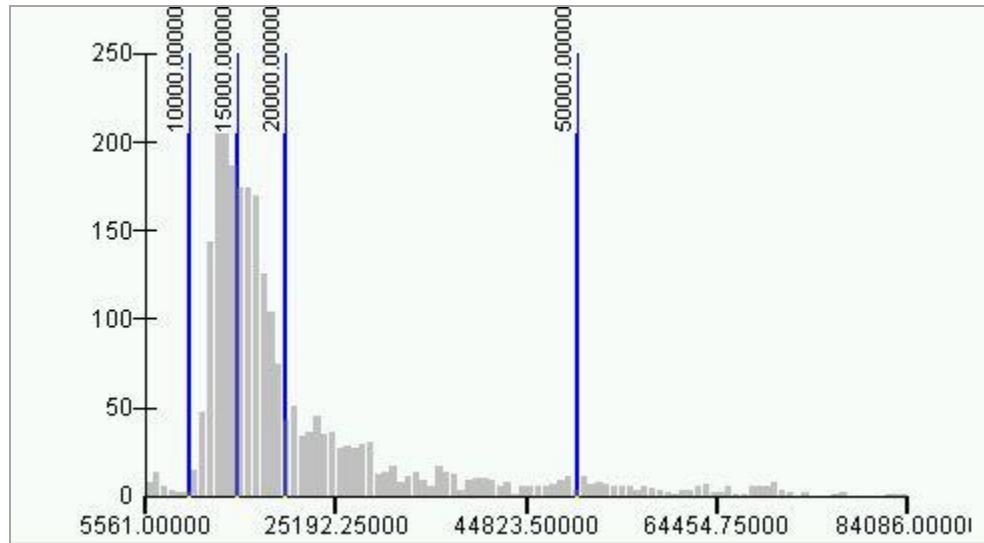
The following chart and statistics were generated by ESRI ArcGIS 9.3.1, and show the general distribution of the site gamma radiation measurements. The horizontal X axis represents the gamma radiation reading levels in cpm (lowest levels to the left). The vertical Y axis represents the frequency of each gamma radiation level.

Count:	2461
Minimum:	5561.00000
Maximum:	84086.00000
Sum:	52341682.00000
Mean:	21268.46079
Median:	16722.00000
Standard Deviation:	12384.19098

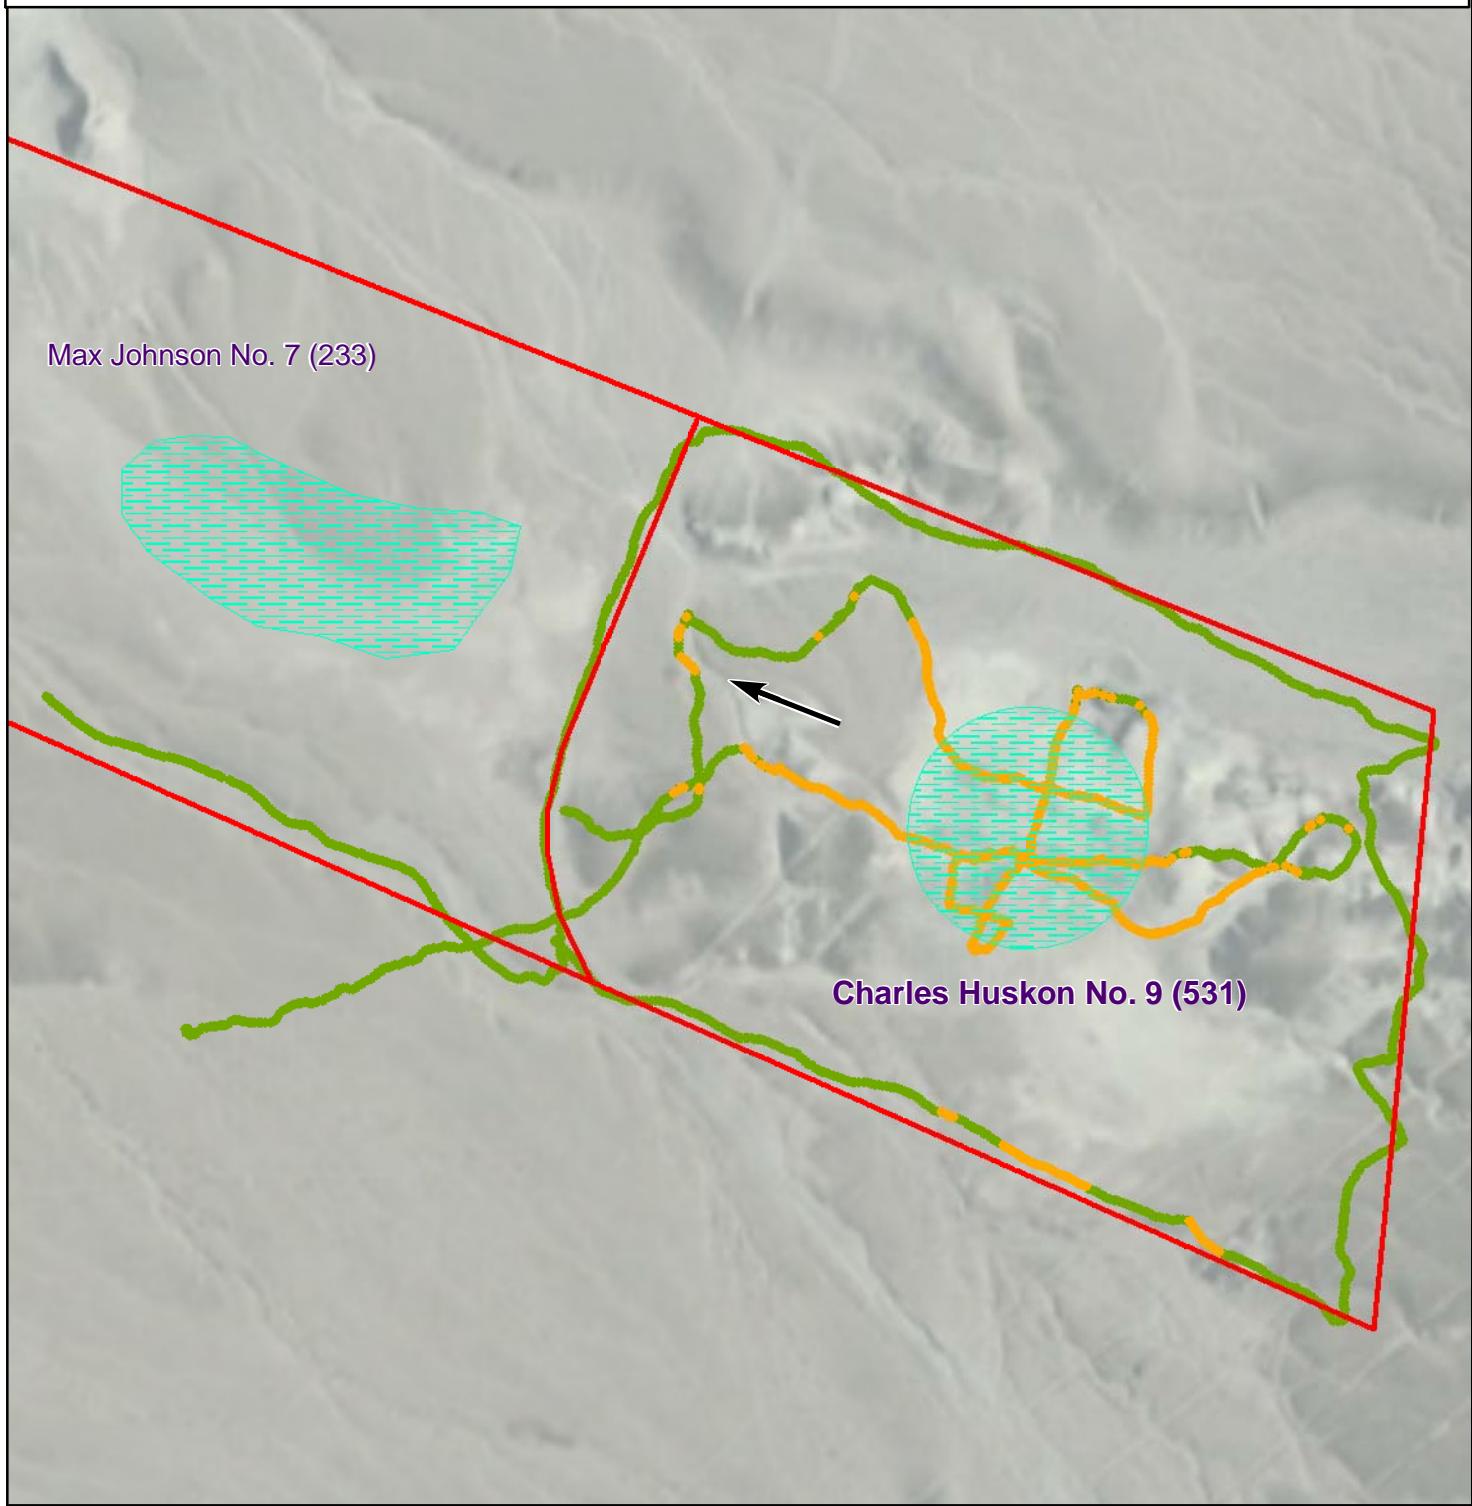
A total of 2,461 gamma radiation measurements were collected from the mine site, ranging from 5,561 cpm to 84,086 cpm. The measurements collected at the reclamation cap were found at a maximum level of approximately 85,000 cpm. The measurements are represented in Figures 1 and 2.

**Figure 1 - Gamma Radiation Measurements, Above Two Times
Background**
Charles Huskon No. 9 (531)
Coalmine Mesa Chapter, Navajo Nation

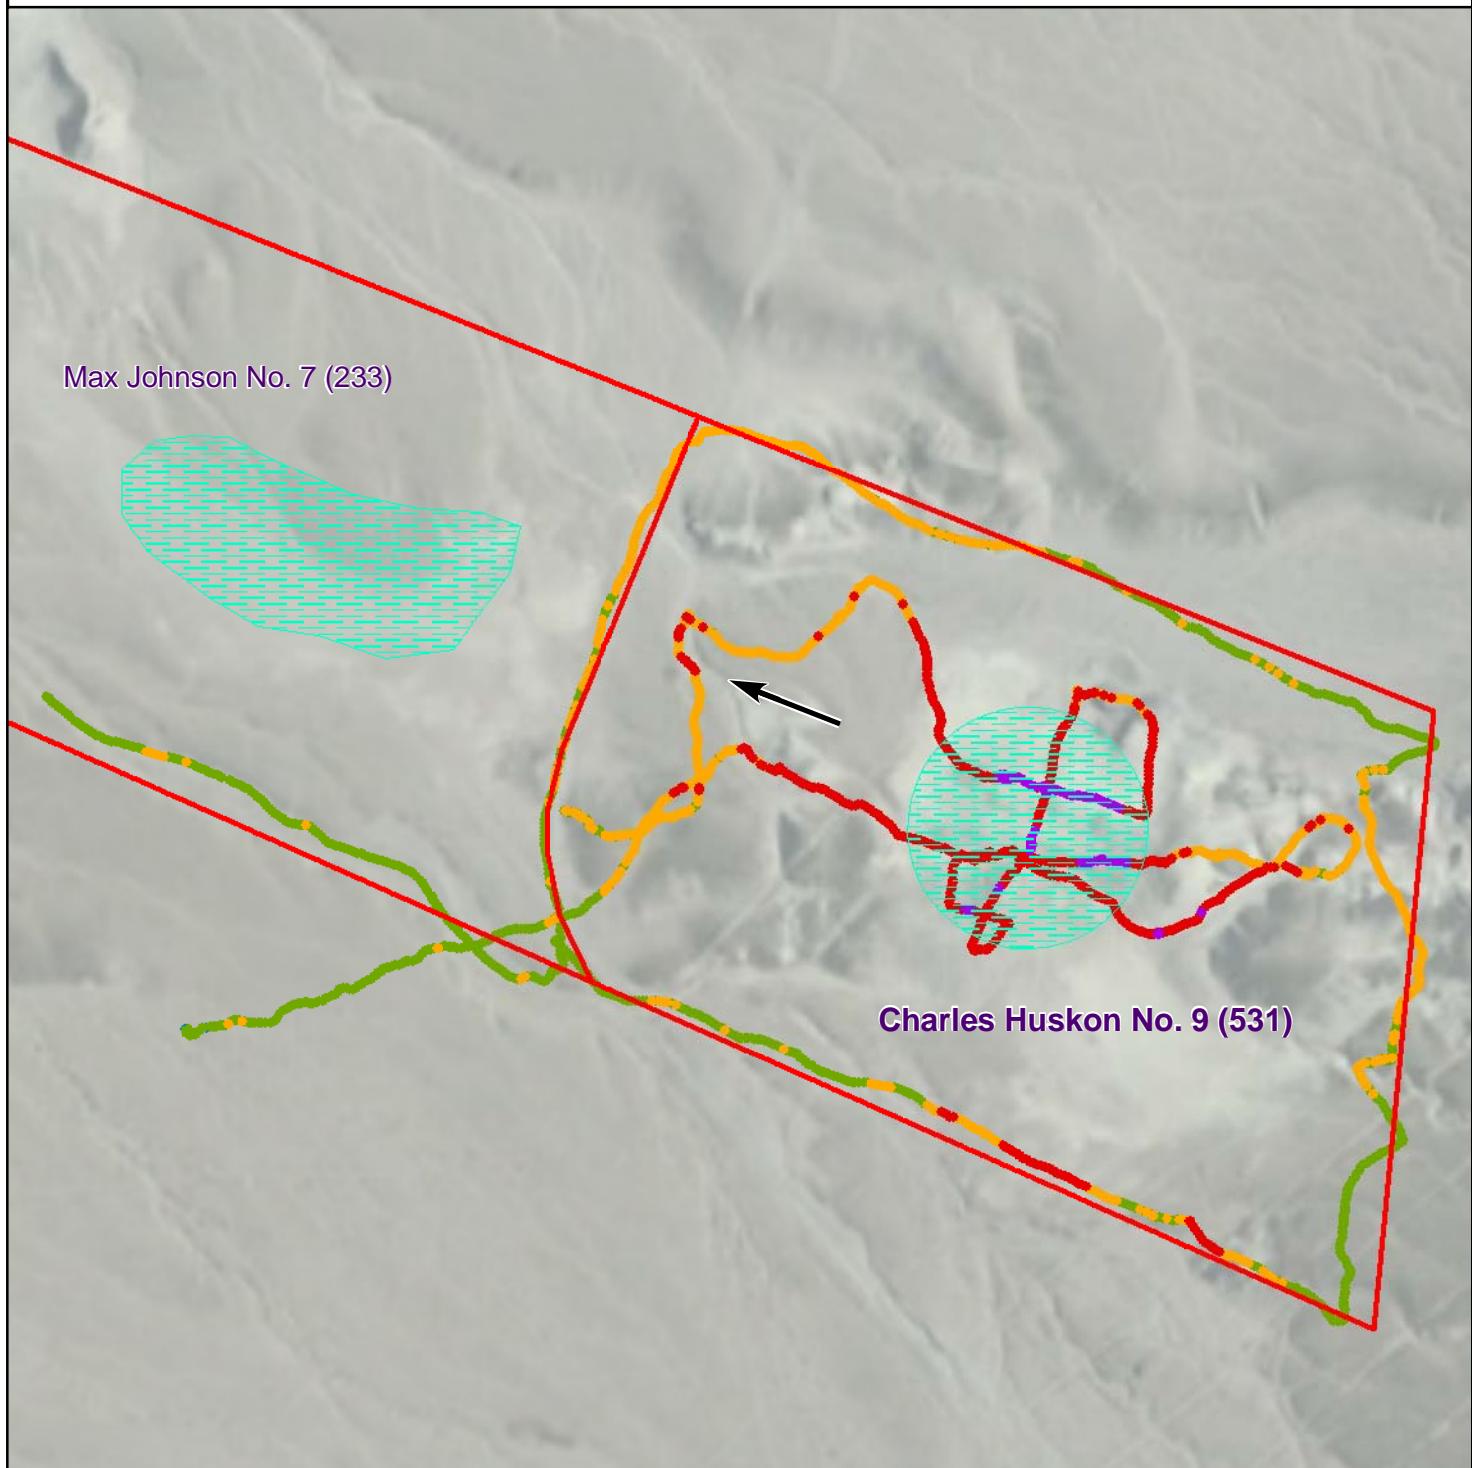
Figure 2 - Gamma Radiation Measurements
Charles Huskon No. 9 (531)
Coalmine Mesa Chapter, Navajo Nation
